CAUCASUS HERITAGE WATCH

MONITORING REPORT

Monitoring Report #1  
June 2021

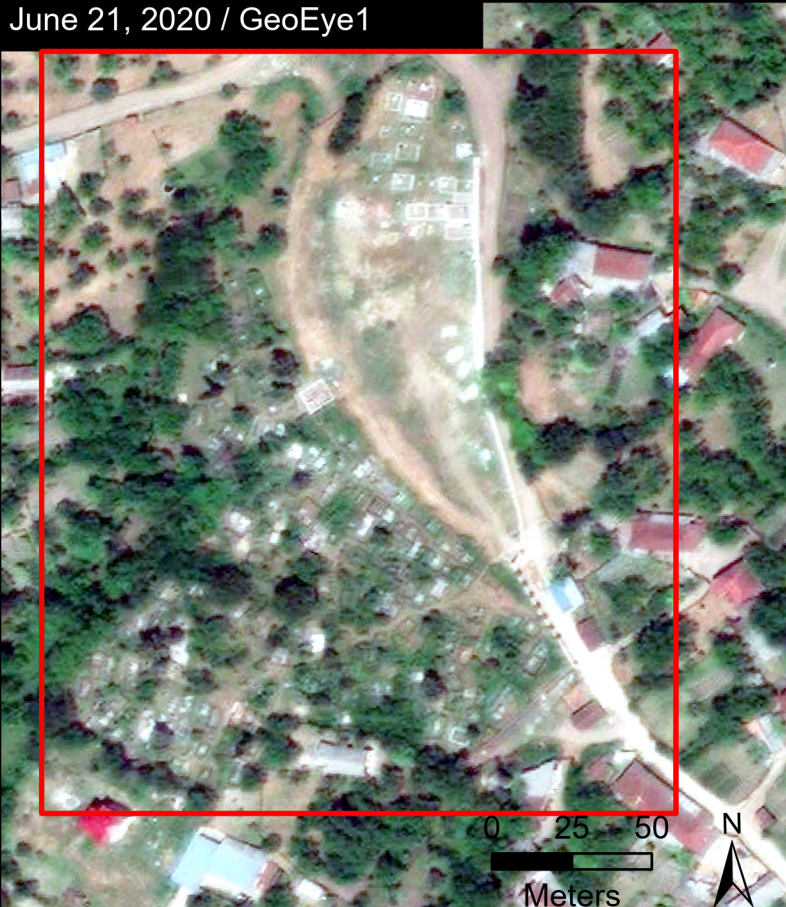
June 21, 2020 / GeoEye1

HT.069-1	Mets T'agher/ Büyük Tağlar Cemetery
Dates	approx. 1800-2020
Baseline Image	2020-06-21 / GeoEye1
Monitoring Image	2021-04-09 and 2021-05-16 / SkySat
Current Status	Destroyed
Notes	The area of this cemetery has been deeply graded with bull dozer scars clearly visible in the April 9, 2021 image. A subsequent image capture from May 16, 2021 shows continued destruction in the area as earth and funerary materials have been pushed into a large berm adjacent to the new road construction.
Alerts	The destruction of this cemetery was the focus of a <a href="#">social media alert that CHW issued on May 4, 2021</a>
Citations	<a href="#">Cultural Heritage Monitoring Lab: Rapid Report (07 May 2021), Virginia Museum of Natural History/Smithsonian Cultural Rescue Initiative.</a>

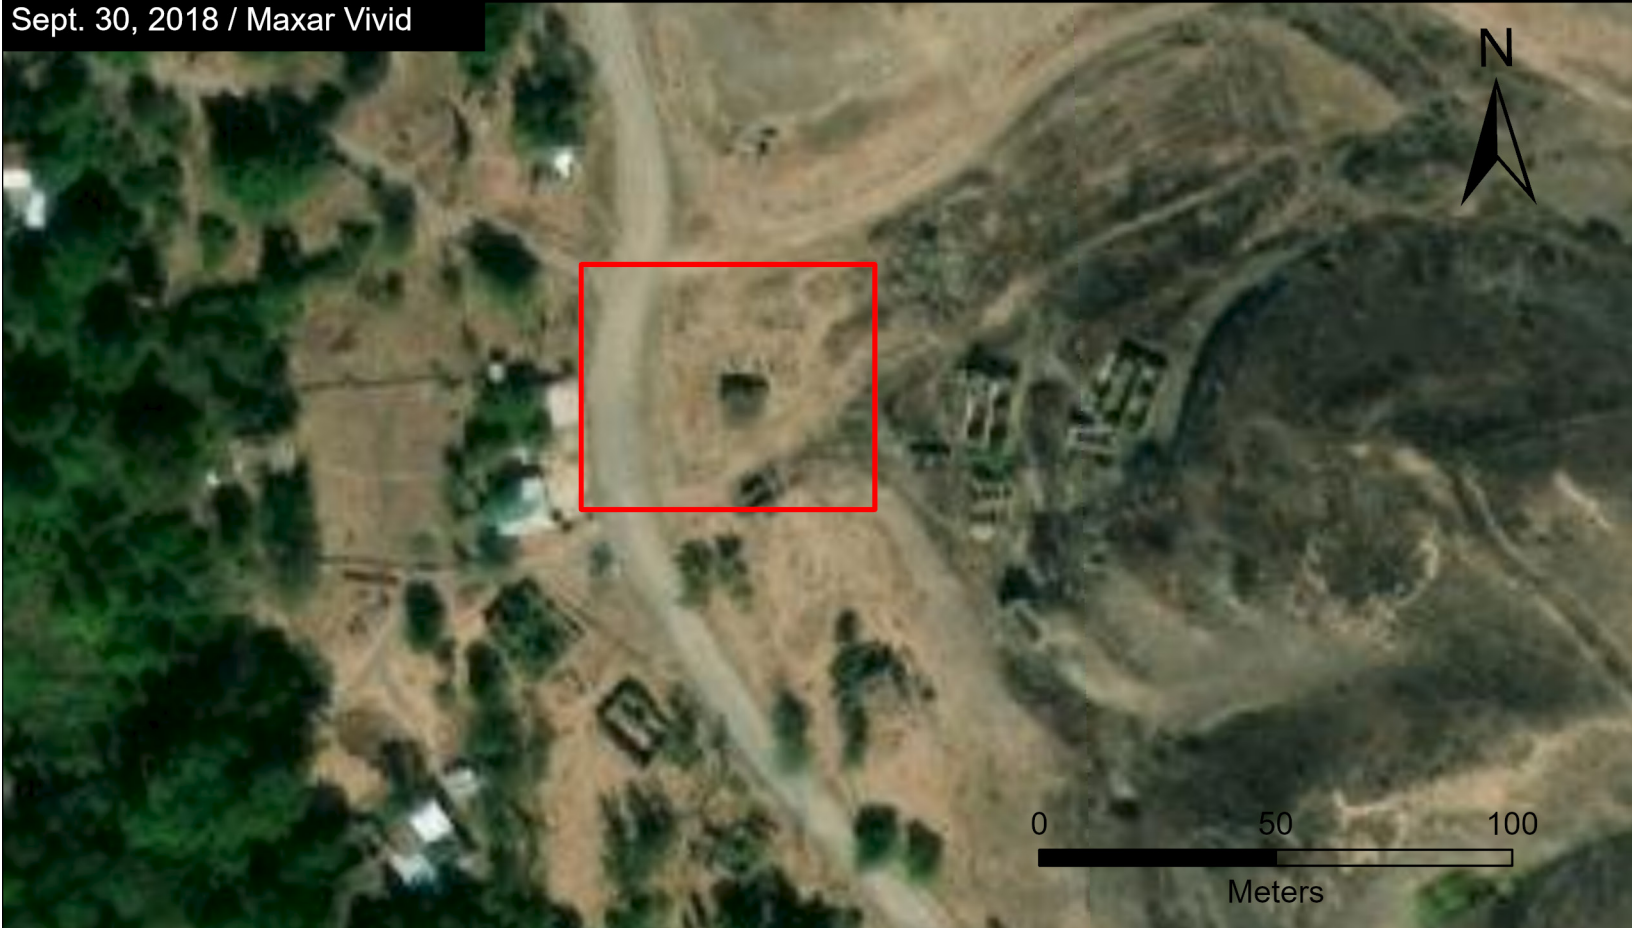
Sept. 30, 2018 / Maxar Vivid

LN.004-0	Aygek Mosque
Dates	18th Century
Baseline Image	2020-09-30 / Maxar Vivid
Monitoring Image	2021-05-12 / SkySat
Current Status	Destroyed
Notes	This 18th century mosque was destroyed by an Azerbaijani road crew in the process of widening the existing route. The destruction was publicized in <a href="#">social media reports</a> on April 14, 2021.

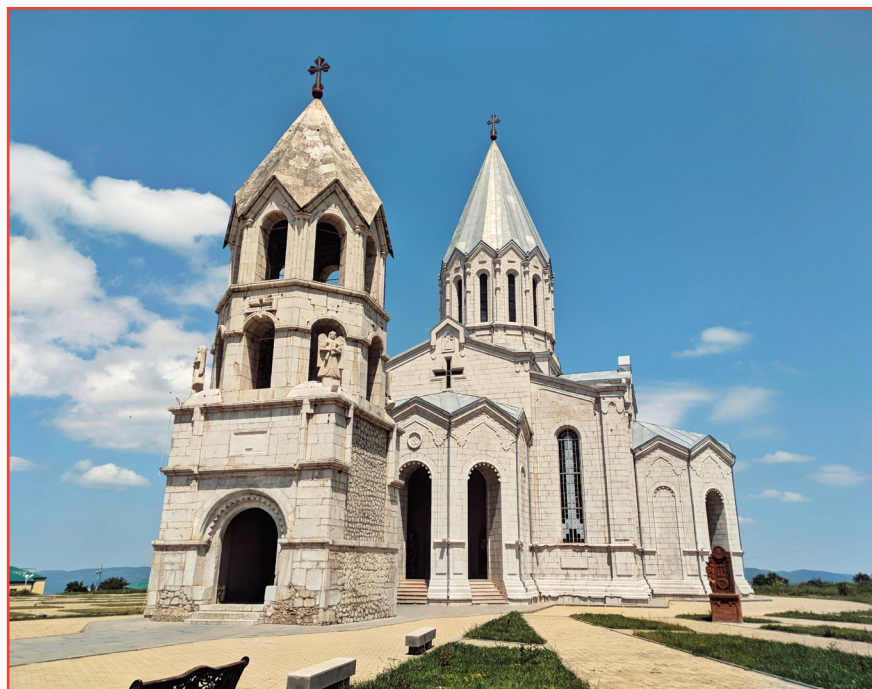
October 25, 2020 / GeoEye1

SH.052-0	Ghazanchets'ots' Cathedral (Shusha/Shushi)
Dates	Constructed 1868
Baseline Image	2020-10-25 / GeoEye1
Monitoring Image	2021-04-10 / SkySat
Current Status	Damaged
Notes	Shell hole visible in the south roof in the April 10, 2021 image has been widely documented as occurring during the 2020 war. CHW's monitoring image also shows damage to the patio northeast of the building and additional damage on territory east. The inscribed stone (SH.052-2) that had been standing on a pedestal a few meters southeast of the detached bell tower appears to have been completely destroyed. Social media since this image has documented the removal of the peaked cupola that topped the central dome. Representatives from Azerbaijan have indicated it is being restored. But the cupola shows no evidence of damage in the available imagery so it is unclear why restoration of this part was necessary.
Image Credit	Photo below 18 February 2018 by Baykar Sepoyan. Licensed under the the Creative Commons Attribution-Share Alike 4.0 International license.

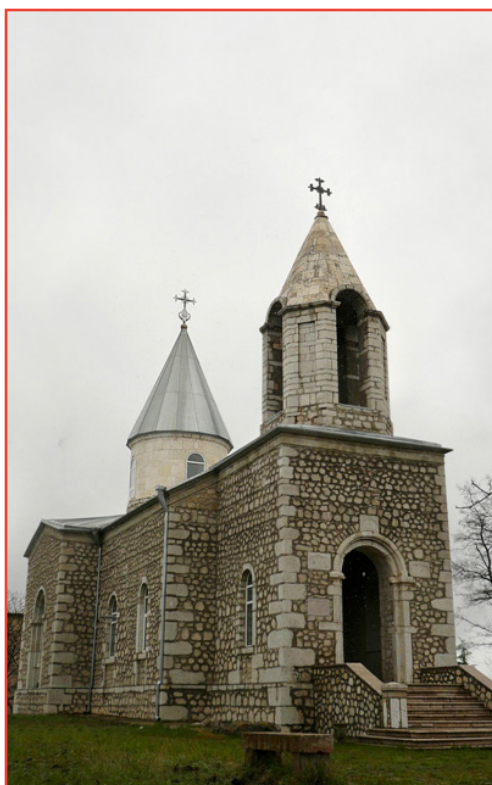
Oct. 25, 2018 / GeoEye1

SH.053-0	Kanach Zham (S. Hovhannes Mkrtich)
Dates	Constructed 1847
Baseline Image	2020-10-25 / GeoEye1
Monitoring Image	2021-04-10 / SkySat
Current Status	Damaged
Notes	The church formerly possessed two cupolas, both clearly visible casting tall peaked shadows in the baseline imagery from October 25, 2020. By April 10, it is clear that both towers have been demolished. While the site experiences some damage during the 2020 war, a February 2014 image available on Google Earth shows that a portion of the eastern cupola was still standing at that time. It is clear from the April 10, 2021 image that both towers have now been destroyed.
Image Credit	Photo below 17 April 2009 by LJ user plusninety. Licensed under the the Creative Commons Attribution-Share Alike 4.0 International license.

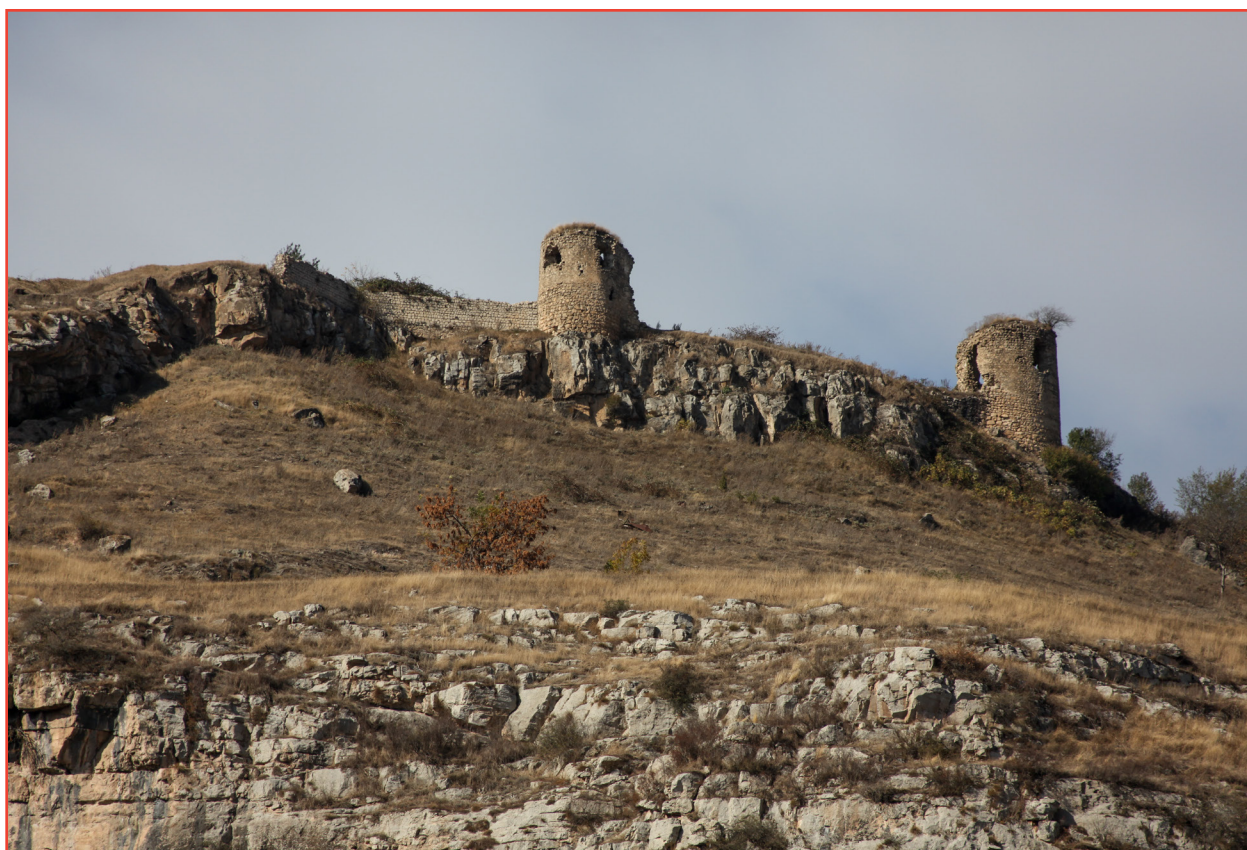
Sept. 14, 2020 / GeoEye1

SH.093-0	Shushi/Shusha Eastern Rampart
Dates	Constructed 1848
Baseline Image	2020-09-14 / GeoEye1
Monitoring Image	2021-04-10 / SkySat
Current Status	Damaged
Notes	This portion of the historic city rampart appears to have been damaged, perhaps during conflict based on the ejecta pattern of some of the debris. The area now appears to host temporary structures (visible with orange and purple roofs). It is unclear what kind of threat these new structures may pose to the rampart.
Image Credit	Photo below 20 October 2012 by Areg Balayan. Licensed under the Creative Commons Attribution-Share Alike 4.0 International license

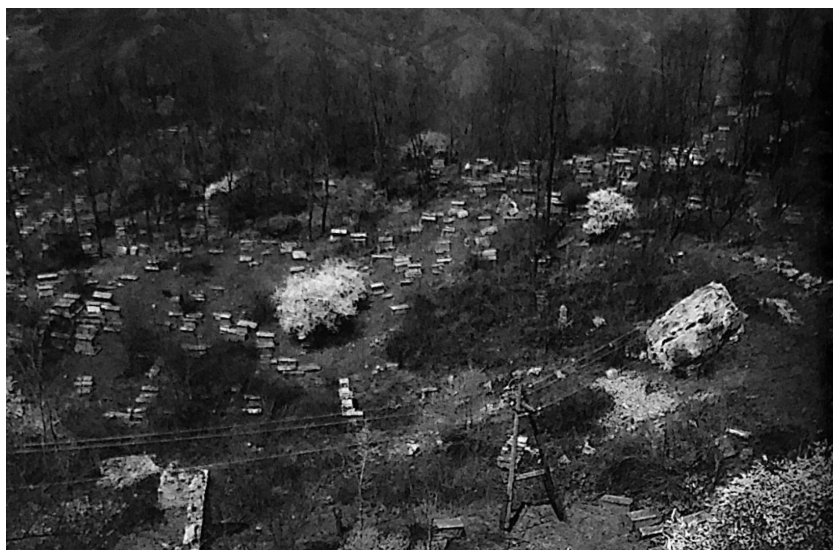
# SH.101-2. Shushi/Shusha Northern Cemetery

SH.101-2	Shushi/Shusha Northern Cemetery
Dates	1834-1920
Baseline Images	2020-09-14 / GeoEye1; 2021-02-14 Maxar; Google Earth
Monitoring Image	2021-04-10 / SkySat
Current Status	Damaged
Notes	The centuries-old cemetery north of Shusha/Shushi has been partially destroyed. A portion of the grounds on the west side of a road leading into the city was leveled in the construction of a building complex. The expansive cemetery, which spans both side of the road, contained 96 tombstones dating 1832-1920 and two 12-13th c. cross stones (khachkars), including the tombs of noble Armenian families (meliks). Although the construction occurred in an area shaded by tree cover, imagery from February 2021 reveals a dense array of tombstones, and documentation provided by Monument Watch details specific plots in the location.
Alerts	Damage to Shusha/Shushi's Northern Cemetery was reported in a <a href="#">social media alert issued on May 17, 2021</a> .

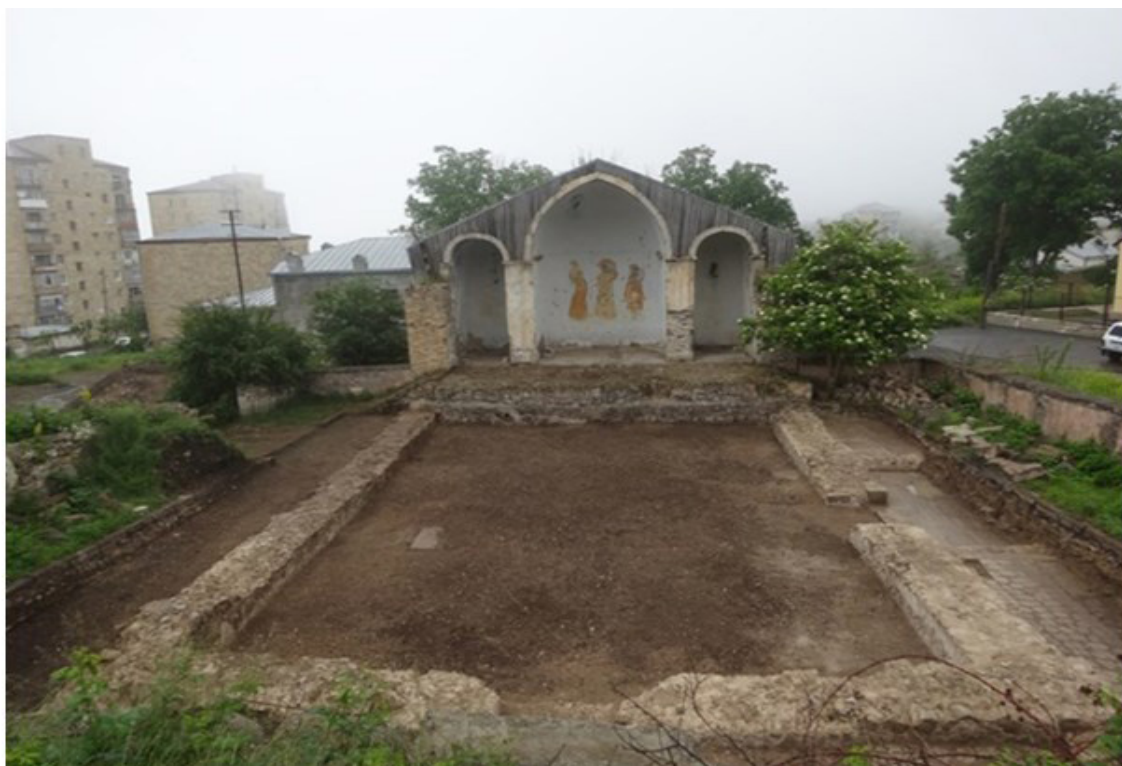
Oct. 25, 2020 / GeoEye1

SH.054-0	Surb Meghrets'ots', Shushi/Shusha
Dates	Constructed 1833
Baseline Image	2020-09-14 / GeoEye1
Monitoring Image	2021-04-10 / SkySat
Current Status	Damaged
Notes	Much of this church was destroyed in the 1960s and replaced by an open-air cinema. But archaeological excavations in spring 2017 exposed the original foundations of the structure beneath the asphalt, including the now-damaged north wall. This wall at the site appears to have sustained damage leading to displacement of building material and an inward bow of the wall, perhaps indicating it has been pushed inwards.
Photo Credit	<a href="#">Vatican Radio Archive</a>

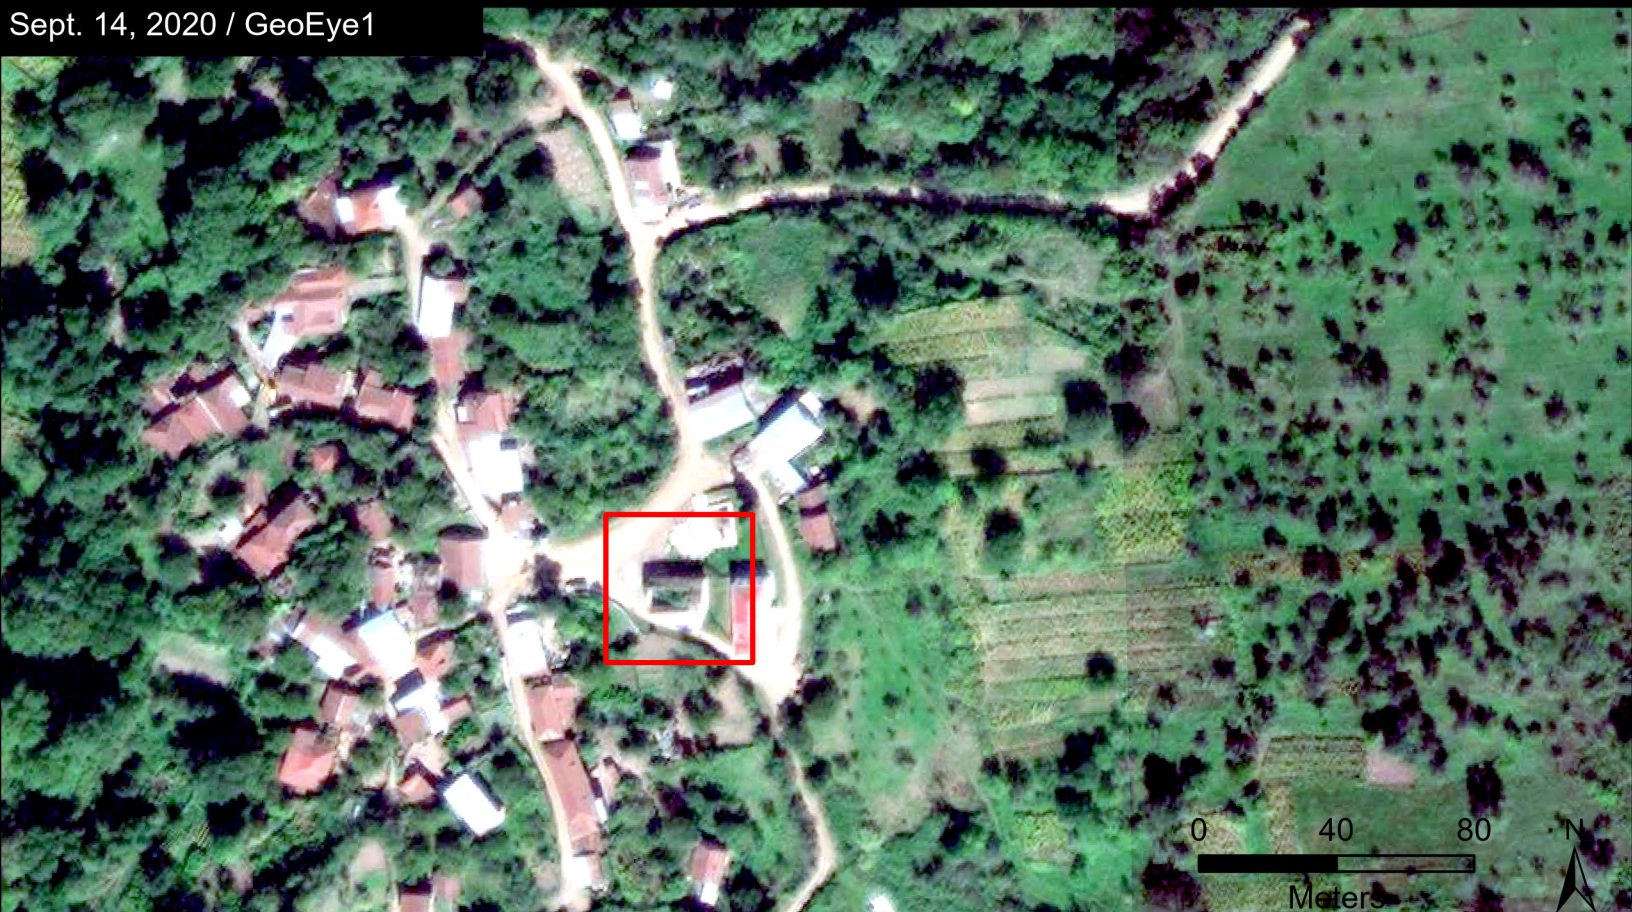
Sept. 14, 2020 / GeoEye1

AN.226-0	Madadkend/Madat'ashen Surb Astvatsatsin
Dates	Constructed 19th century
Baseline Image	2020-09-14 / GeoEye1
Monitoring Image	2021-05-13 / SkySat
Current Status	Threatened
Notes	This already fragile 19th century church sits just 50m from extensive earth moving adjacent to the road. Satellite imagery shows an extensive area of bulldozing just south of the road in what formerly was agricultural territory.

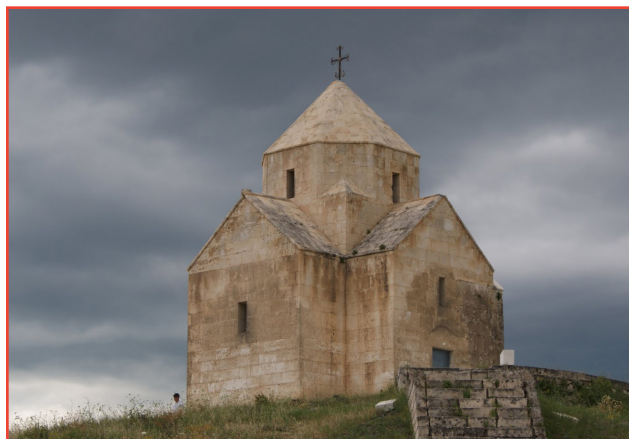
Oct. 13, 2020 / WorldView2

AN.344-6	Vank'asar Church
Dates	Constructed 7th century
Baseline Image	2020-10-13 / WorldView2
Monitoring Image	2021-04-16 / SkySat
Current Status	Threatened
Notes	CHW's April 19, 2021 threat alert for Vank'asar focused on two key changes in the satellite imagery for the site. First, we noted the presence of heavy equipment in the parking area right in front of the church including what appears to be 1-2 trucks. Second, we noted a 20 x 10m temporary structure just northeast of the parking area. Despite calls for clarification, the purpose of these developments has not been communicated to date to either CHW or the media outlets that amplified the alert.
Alerts	CHW released a <a href="#">social media alert on April 19, 2021</a> .
Media	<a href="#">Activity at Recaptured Armeinan Church in Azerbaijan Raises Concern</a> (RFE/RL April 20, 2021). <a href="#">Церковь на землях, перешедших под контроль Баку: опасения утратить древний памятник</a> (Радио Азаттык April 22, 2021)

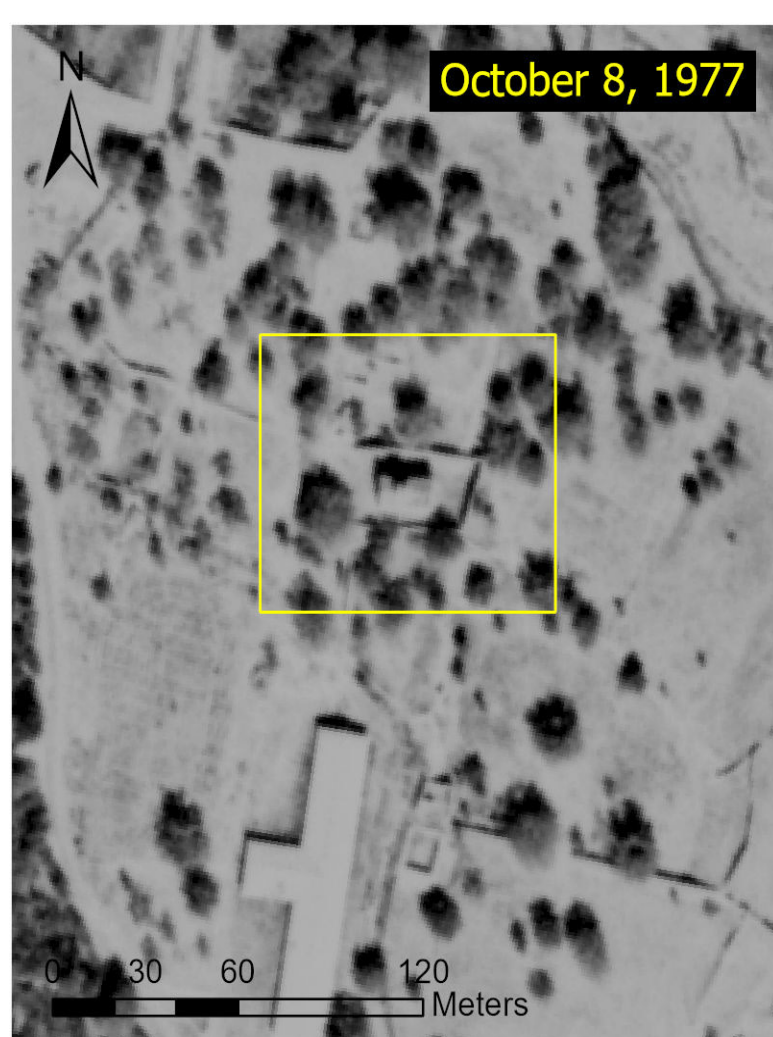
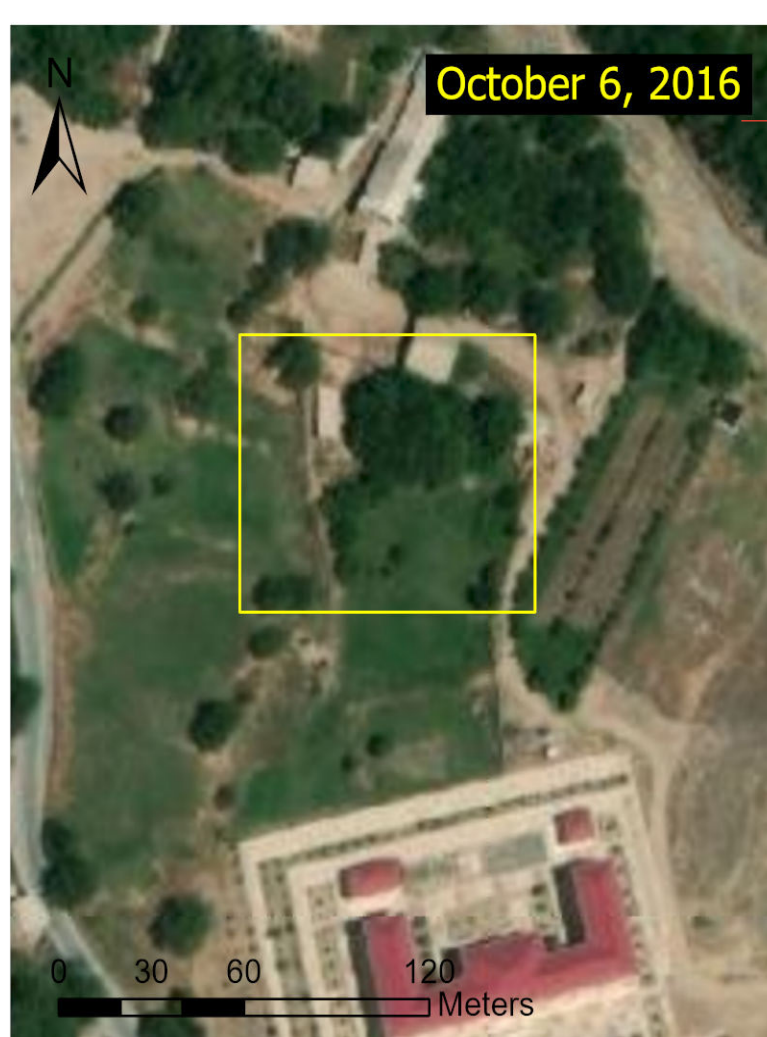
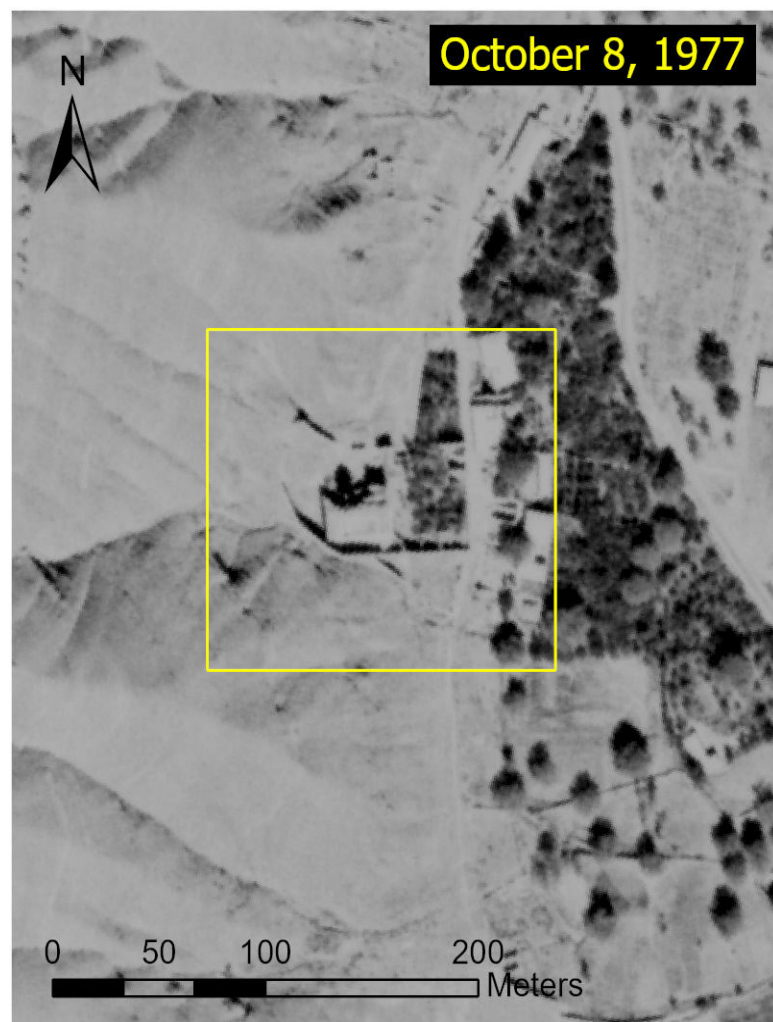
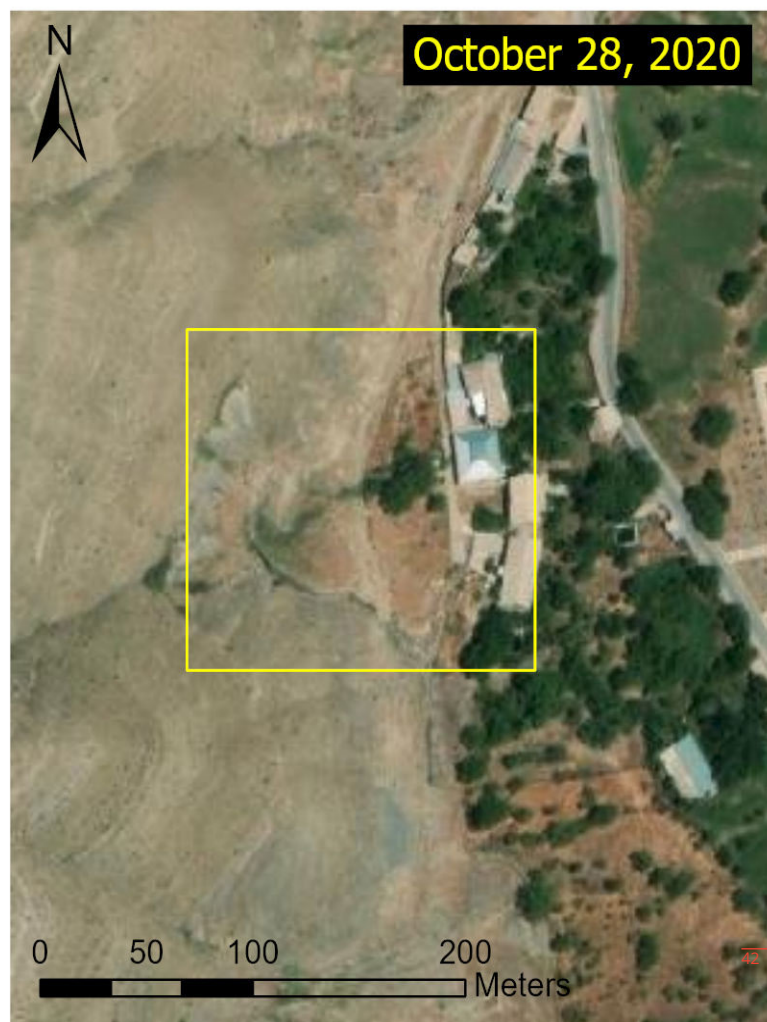
Recent investigations indicate the near total destruction of Armenian ecclesiastical structures in the Azerbaijani province of Nakhichevan. CHW has already provided documentation of church destruction in the town of Agulis, exemplified in the images at right, and will be extending this research.

During this reporting period, CHW provided satellite documentation for an investigative study by Simon Maghakyan that appeared in [The Art Newspaper](#) on the destruction of Armenian churches in the village of Agulis, located in Azerbaijan's Nakhichevan Autonomous Republic. We unearthed declassified imagery captured in 1977 by the US government's KH-9 Hexagon photographic reconnaissance satellite, allowing us to confirm the obliteration of seven churches. Maghakyan was able to use interviews and archival research to date the destruction events to the late 1990s. Using declassified Cold War satellite imagery, CHW's historical research can provide a powerful tool for exposing past acts of cultural erasure.
